Surface Examination Report
Orderville, Muddy Creek Gemstone Leases:
ML-19890 & ML-41355
May 10, 1996

Date of Inspection: April 29, 1996

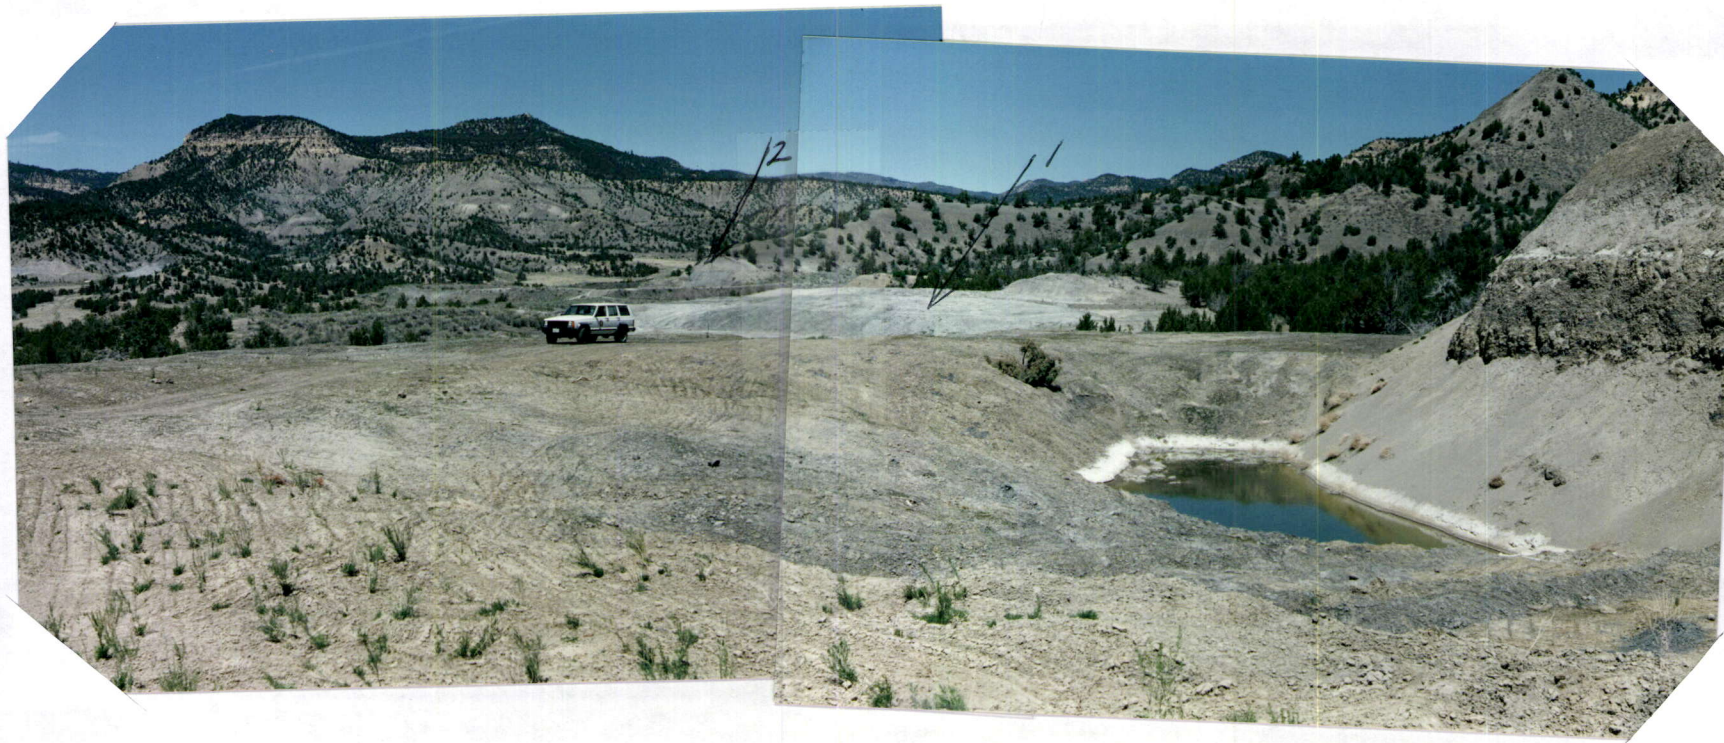
Area 1 Most of this area had been regraded and re-seeded except for a small pit, which was filled with water, measuring approximately 135 feet by 60 feet; .18 acres, remains unreclaimed. See photograph # 1. Mr Johnson choose not to fill the unreclaimed pit area as it would be the site of future excavation. See accompanying summary of reclaimed areas which are an update of Mr. Munson's November 22, 1995 summary report.

Photo # 1. Looking north from the south end of the unreclaimed pit on Area # 1. Note furrowed surface with re-seeded grass growing in the furrows. Arrow # 1 shows the location of Area # 2 and arrow # 2 shows the location of Area # 3.

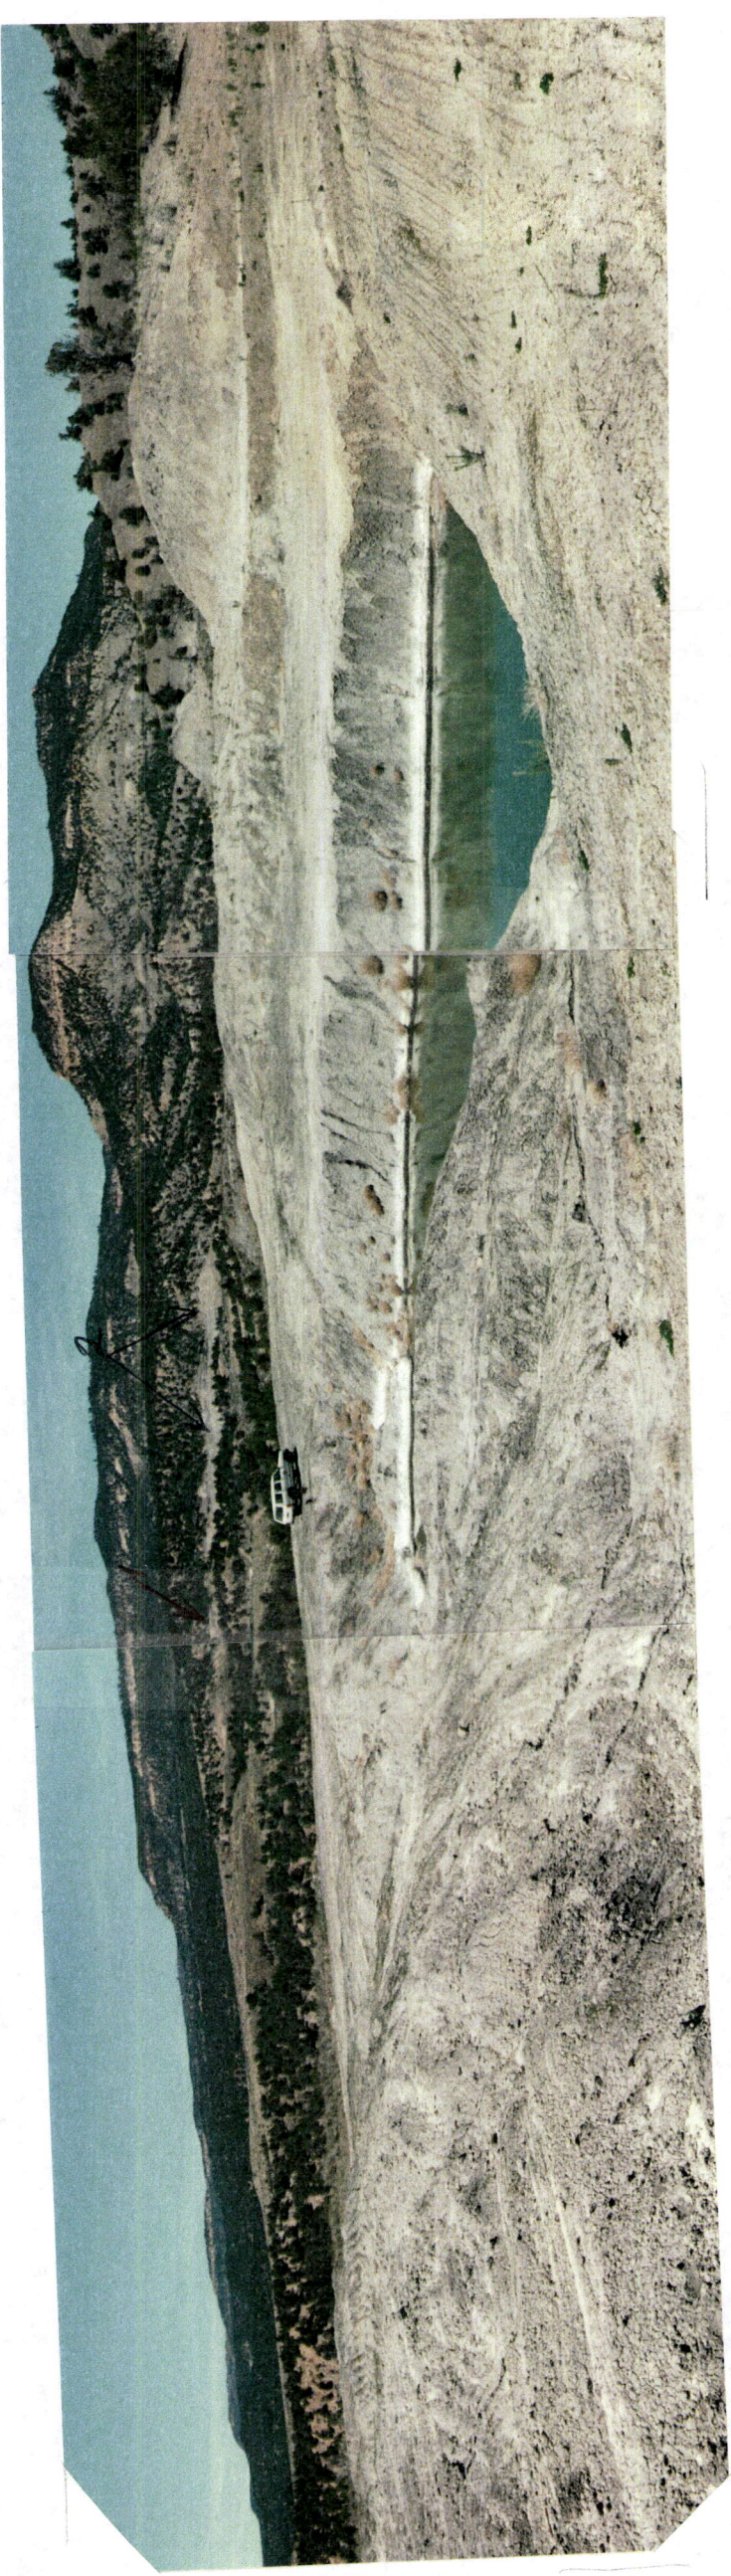
Area 2 As with area 1 most of this area had been regraded and re-seeded. There also remains a water filled pit on area 2 which Mr. Johnson left open for future mining. The unreclaimed area is approximately 117 feet by 135 feet, or approximately .36 acres. See photograph # 2 and summary of reclamation.

Photo # 2. Looking west from the east side of the unreclaimed pit on Area # 2. Note furrowed surface with re-seeded grass growing in the furrows. Arrow # 1 shows the locations of Areas # 4 & 5. Arrow # 2 shows the location of disturbances created by Mr. Rex Harris on his unpatented lode mining claims on Federal land.

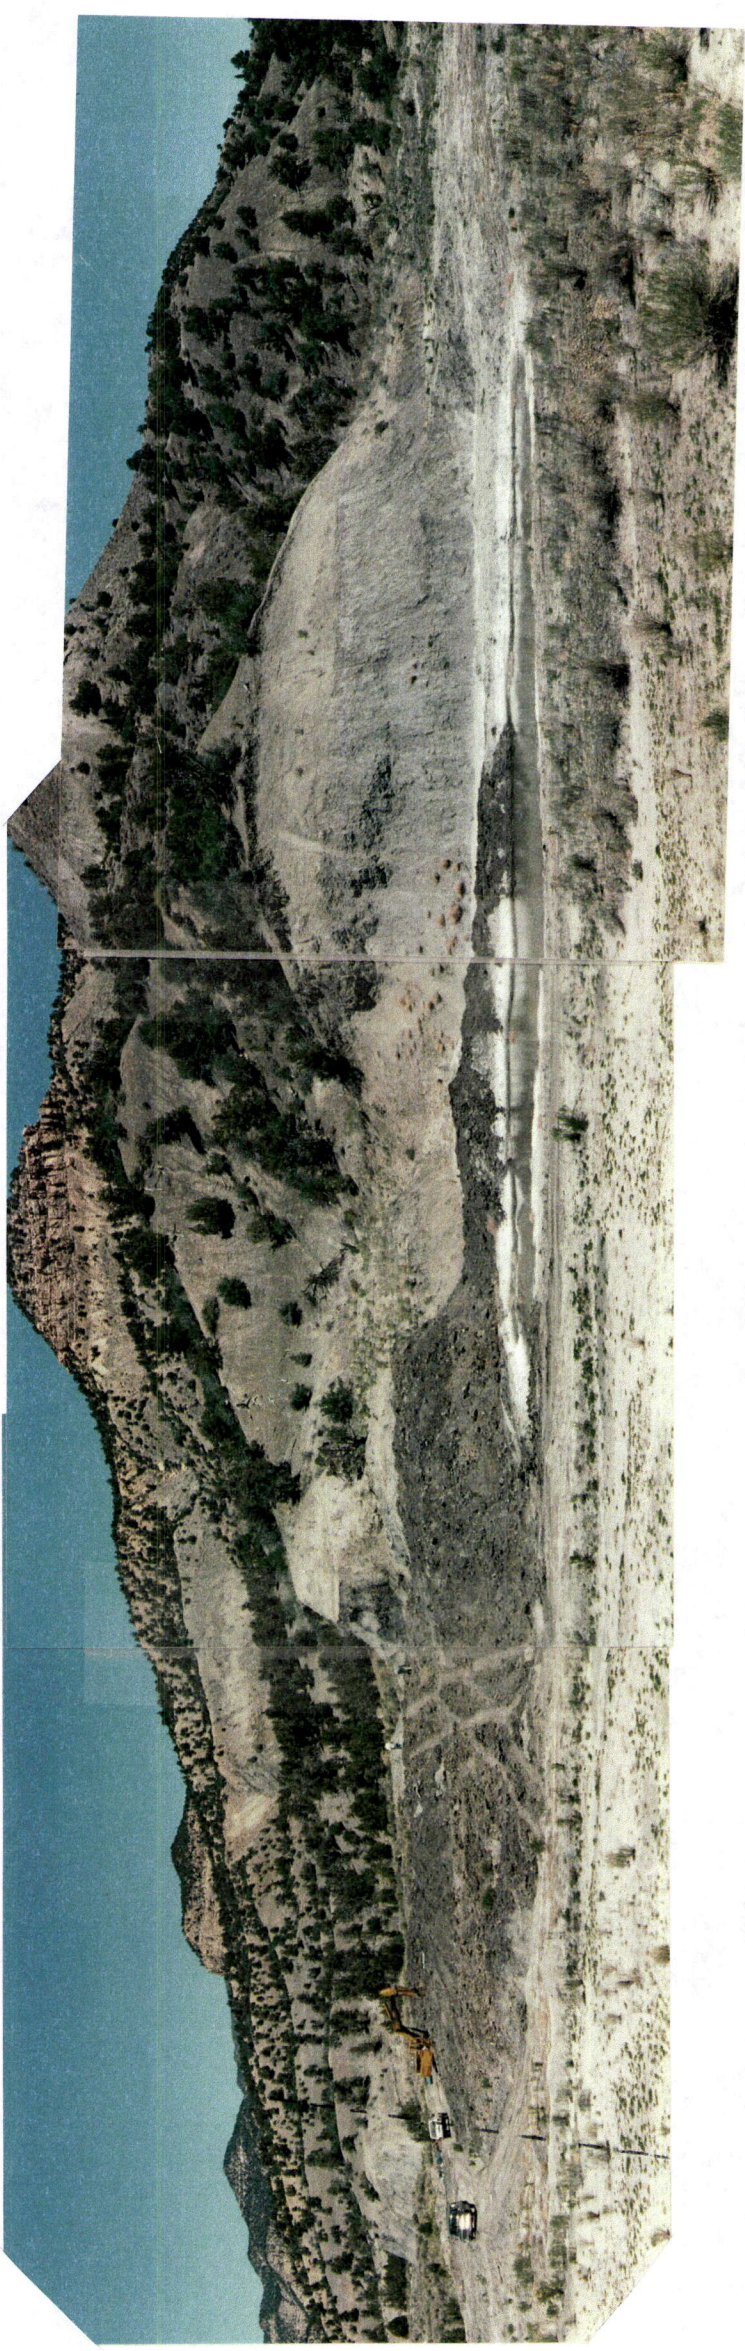
Area 3 This is the site where Mr. Mike Caruso was mining on the Johnson sublease ML-41355. This is also the area from which Mr. Johnson was removing nodules on the date of this inspection. There has been no additional reclamation on this site since Mr. Munson's inspection

of November 21, 1995. The unreclaimed area remains at 3.27 acres. Mr. Johnson will re-contour and re-seed a portion of this area in the fall of 1996. A track-hoe belonging to Mr. Mike Caruso remains on the site. See photograph # 3 and summary of reclamation. Photographs # 4 and 5 show discarded oil drums and oil spills that remain on the property.

Photo # 3. Looking north onto area # 3 which is the site from which Mark Johnson was excavating nodules on the morning of April 29, 1996. There has been no reclamation performed on this site. The track-hoe that is depicted belongs to Mr. Mike Caruso who was removing nodules from ML-41355 with only the verbal consent of the sublessee. Mr. Johnson will reclaim part of this site in the fall of 1996. The dashed line represents the west boundary line of ML-41355.

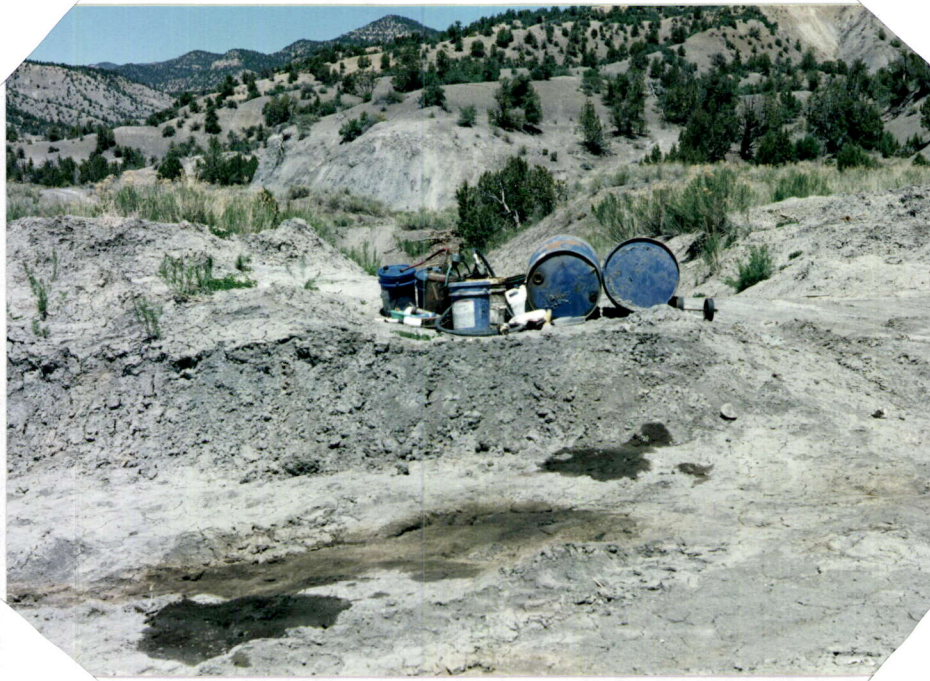
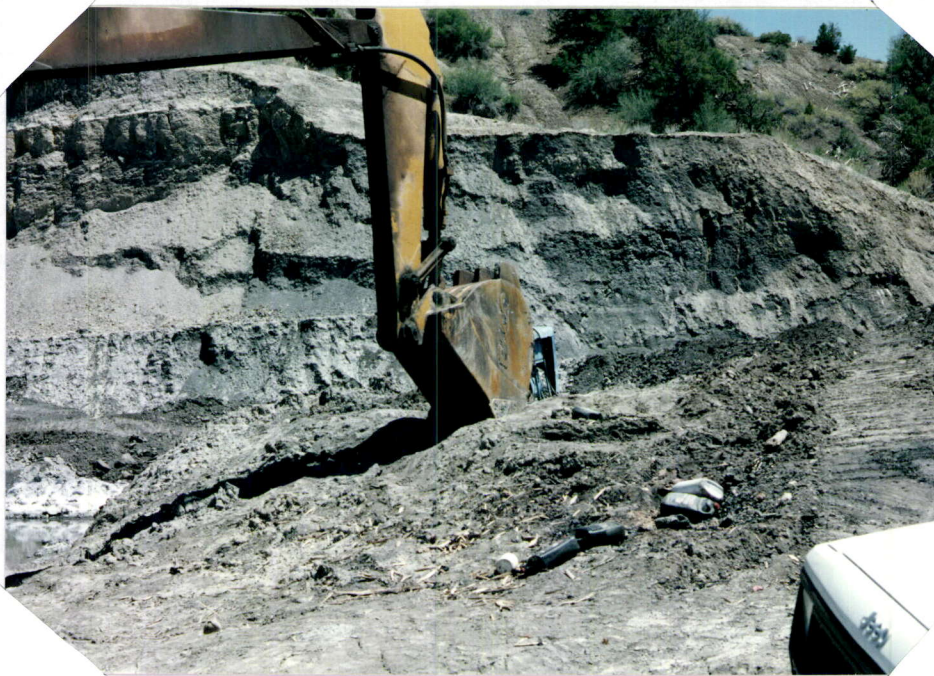
Photo. # 4 & 5. Discarded oil drums, other oil containers and oil spills on lands held under ML-41355.

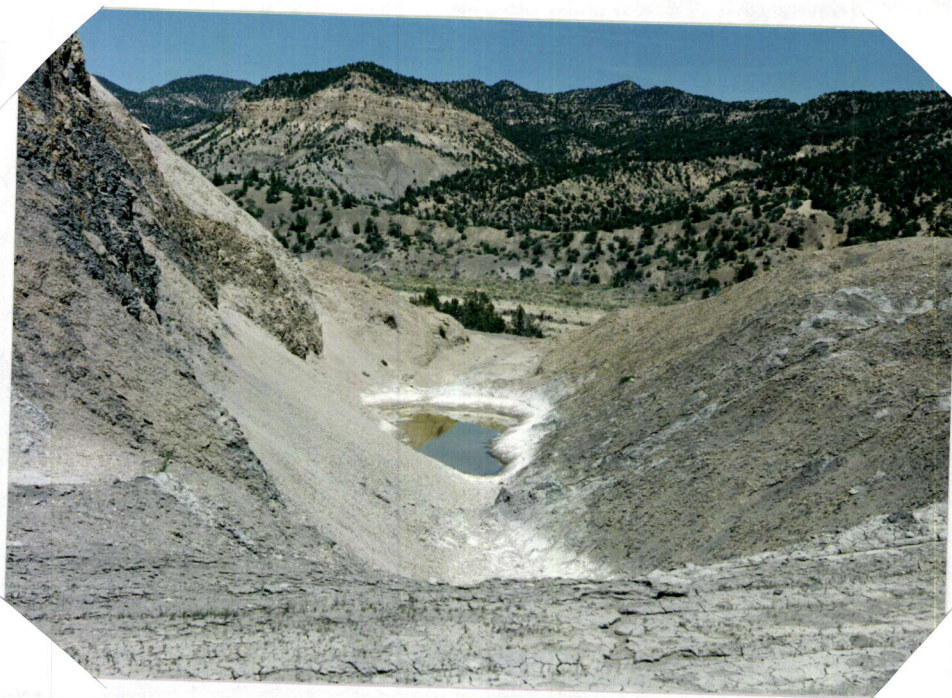
Area 4 This area lies on ML- 19890 and is referred in Mr. Munson's November 22 1995, report as the "Dogleg" area. There has been no additional reclamation on area # 4. Un-reclaimed disturbance remains at .2 acres. See photograph # 7 and summary of reclamation.

Photo. # 6. Looking northeast onto old excavation in area # 4. This area is referred to in the Munson, November 22, 1995 report as the Dogleg area.

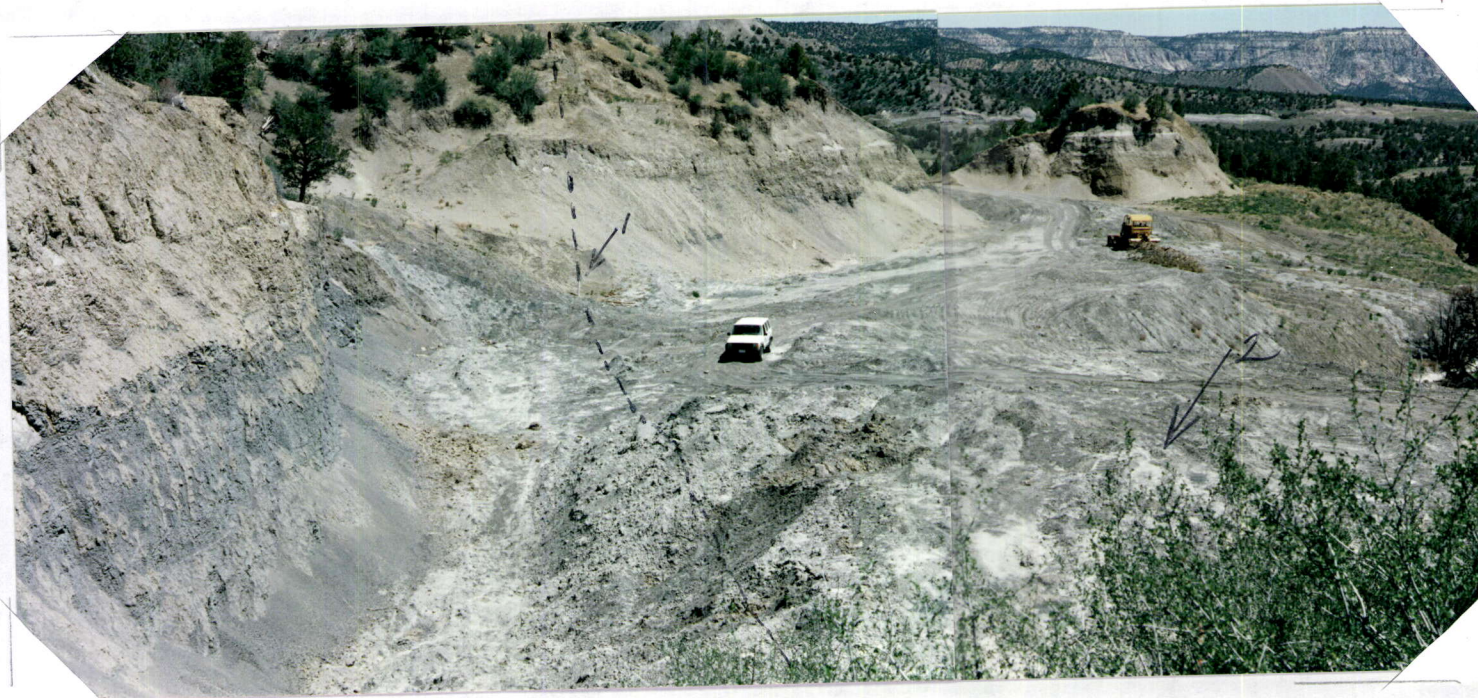
Photo. # 7. Looking east along the boundary line between the Harris unpatented mining claims on Federal land, to the left of the dashed line, and on Trust lands to the right of the dashed line. Arrow # 1 indicates the position of one of the Harris claim corner monuments. Arrow # 2 shows the approximate position of the refilled pit that was created by Mark Johnson as part of mining operations on area # 5. Note the bulldozer parked on Trust lands. This bulldozer is believed to belong to Mike Caruso who was mining for Rex Harris.

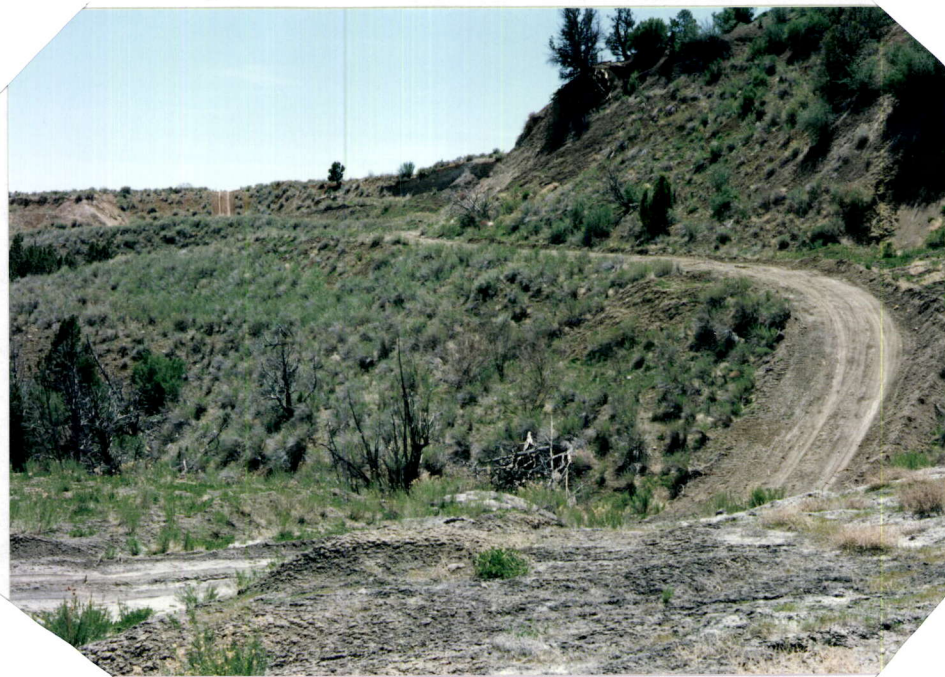
Area 5 Area 5 is adjacent to Federal land on which Mr. Rex Harris was conducting mining operations in 1995. Mr Harris was removing nodules along the boundary between Trust lands and his unpatented mining claims in the S $\frac{1}{2}$ SW $\frac{1}{4}$ of Section 25, T. 40 S., R. 8 W. and deposited the overburden on Trust lands along the northern boundary of the NE $\frac{1}{4}$ NW $\frac{1}{4}$ of Section 36, T. 40 S., R. 8 W, which is held by ML-19890. Mr. Harris used this overburden to fill and reclaim an excavation created by Mark Johnson on ML-19890. Presently area # 5 can be considered regraded and re-seeded thus there remains no unreclaimed land in area # 5. See photograph # 8. There is also a bulldozer which is apparently the property of Mr. Mike Caruso parked on Leasehold ML-19890. A new road apparently created by Mr. Harris traverses a portion on the lands held under ML-19890. See photograph # 9 and summary of reclamation.

Photo. # 8. Looking south from near the bulldozer as seen in photo. # 7 onto a newly opened road across lands encompassed in ML-19890. This road was totally revegetated and it is believed that it was reopened by Rex Harris.

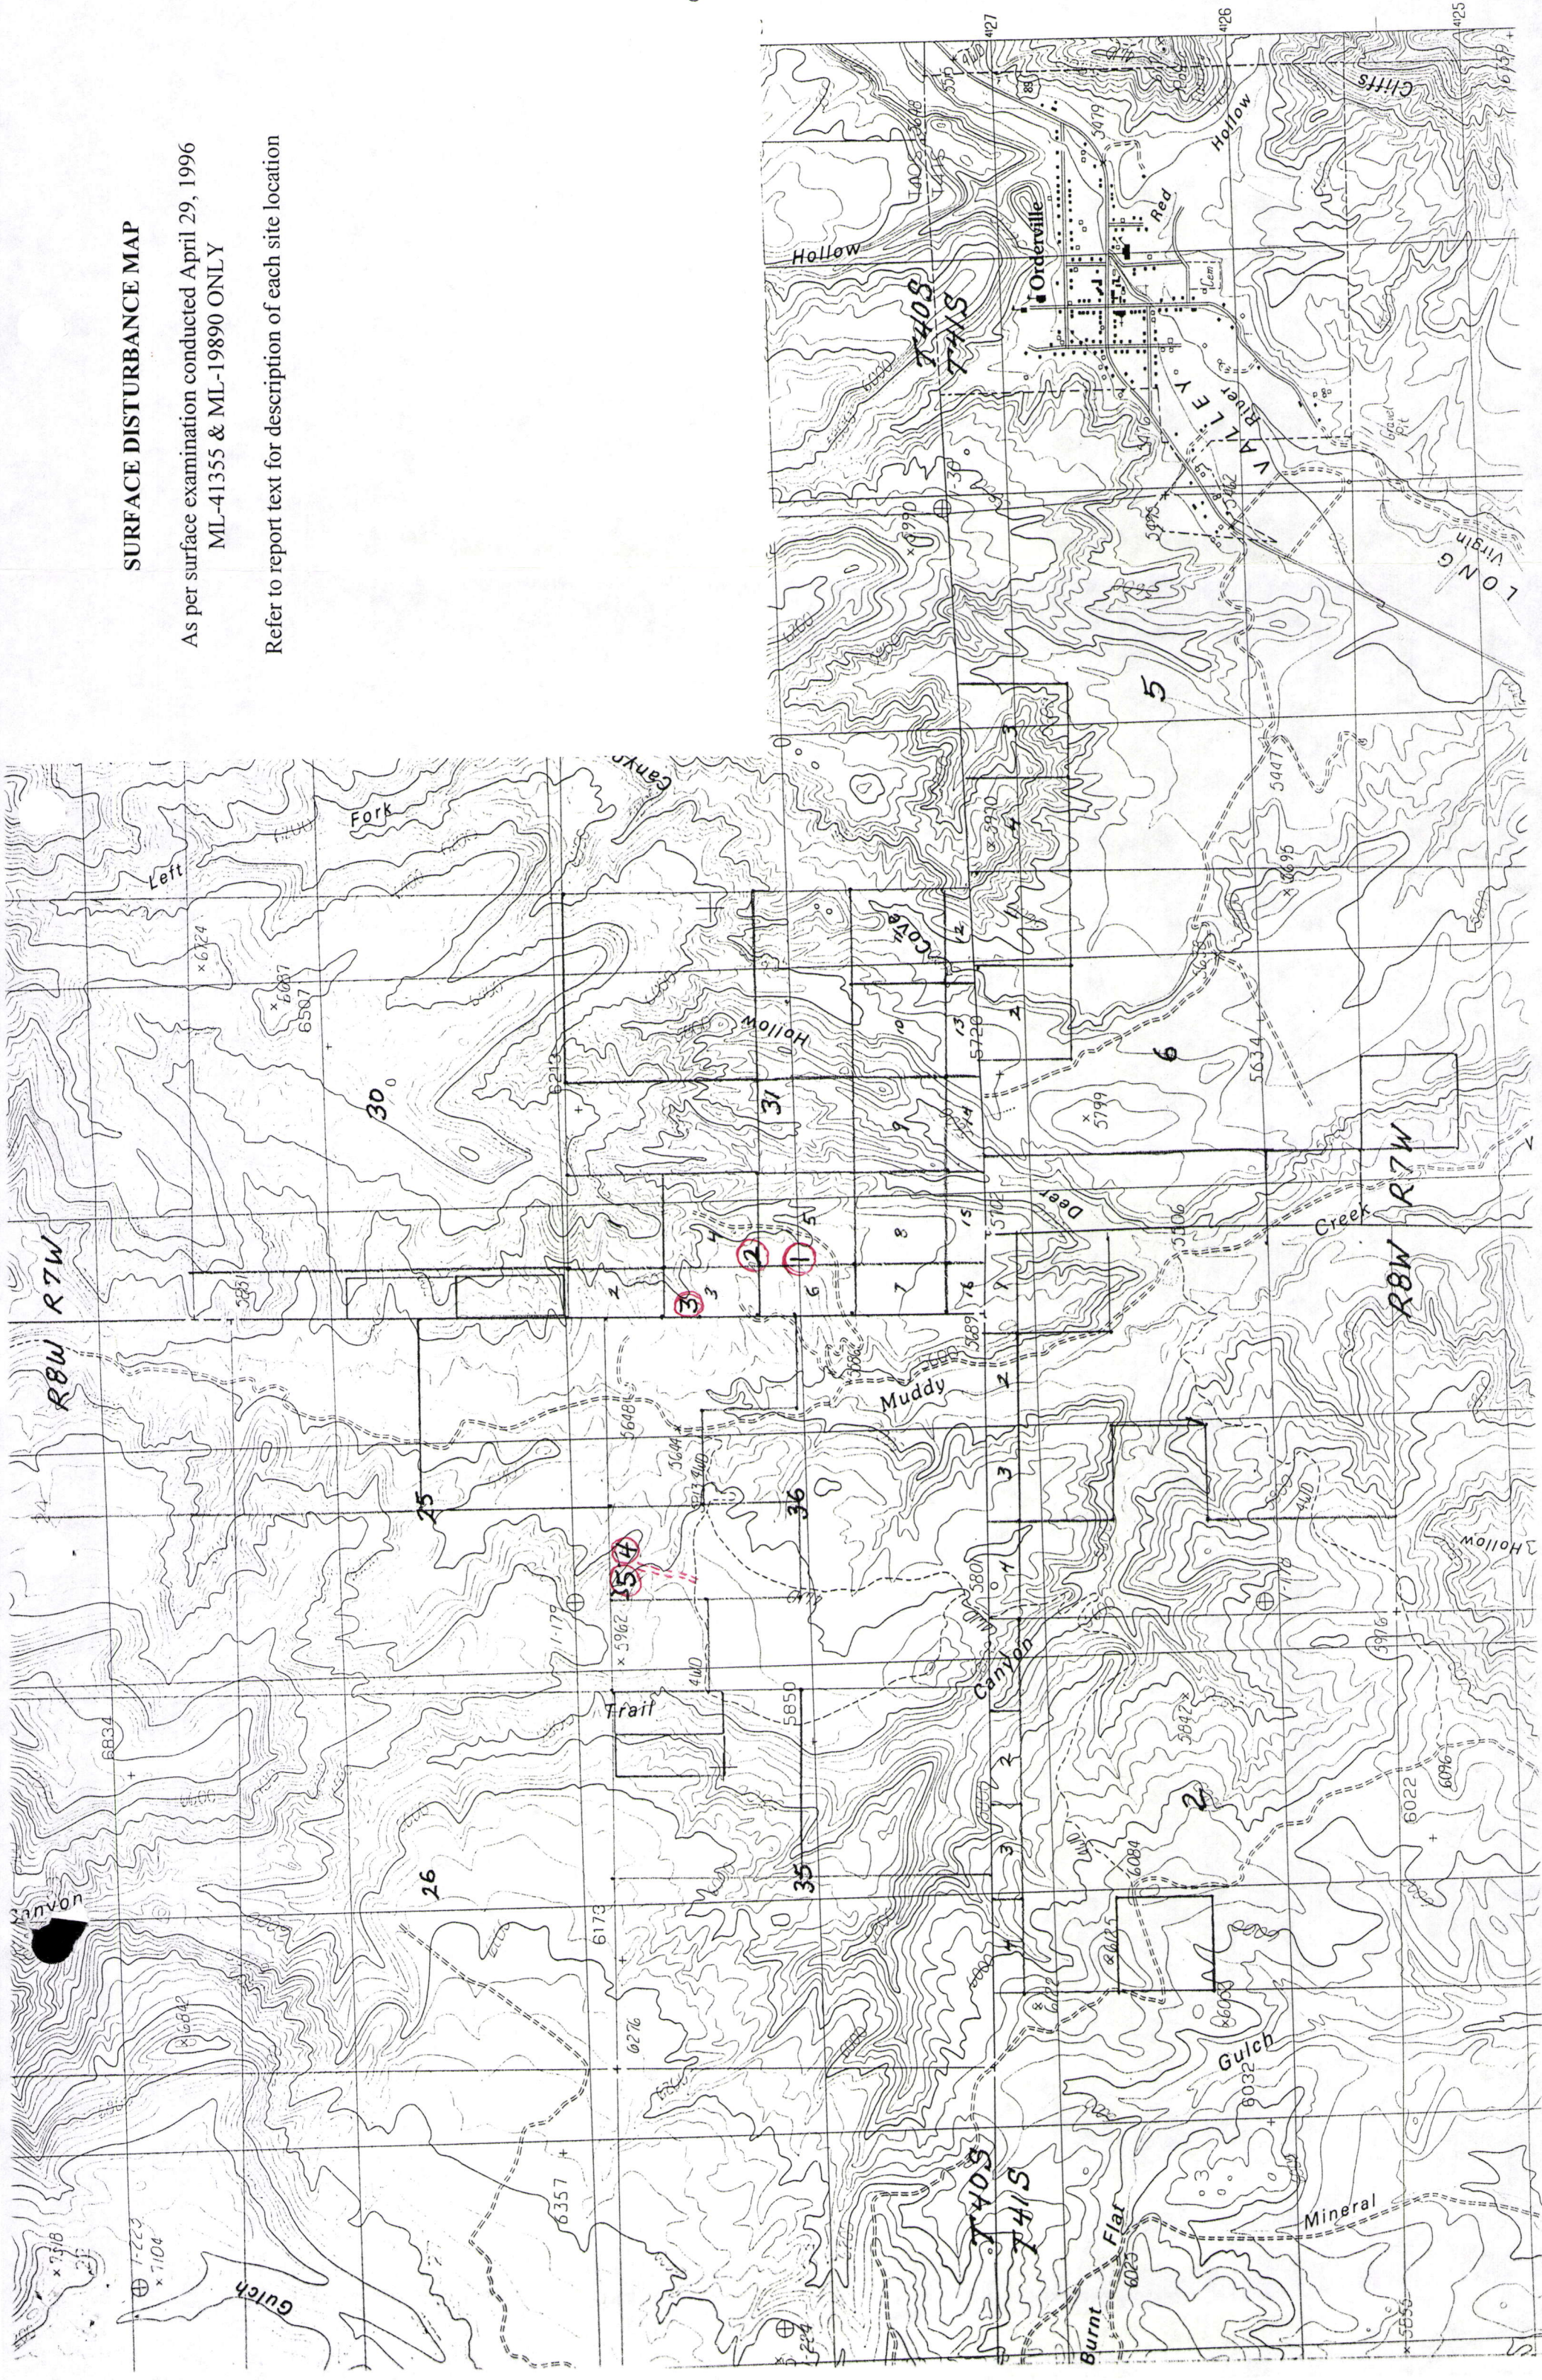
As per surface examination conducted April 29, 1996
ML-41355 & ML-19890 ONLY

Refer to report text for description of each site location
